Manhole Inspection Summary

Manhole # S05YY1010MH

Insp Date: **9/25/06 1:47 PM**

Location Address: **3017 GLEN AVE**

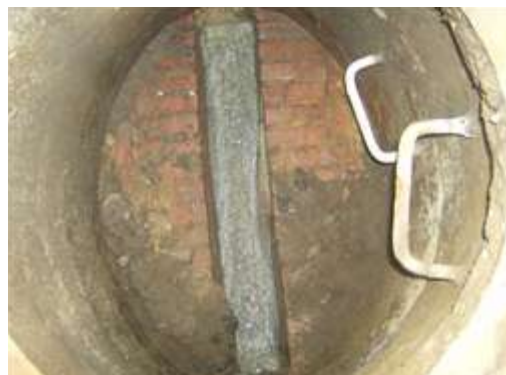
Top View

Frame leaks. Adjustment deterioration and infiltration. Corbel and Barrel infiltration. Evidence of surcharge - Bench

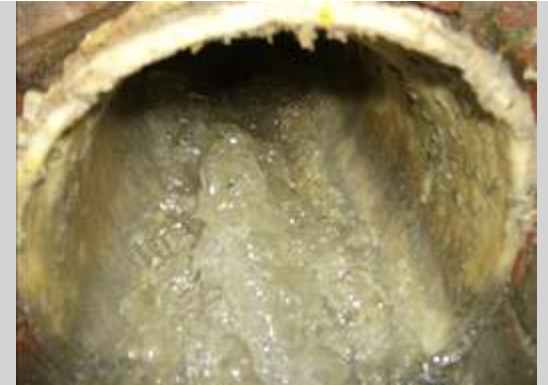
8 in. Circular Gravity Sewer Pipe Out @ 12 O'Clock

Deposits: ☐ None ☐ Mud ☐ Sludge ☐ Debris ☒ **Grease**

Silt Depth: **0** (in.) Deposits Extent: **Light**

Infiltration: **Evidence** Pipe Seal Cond: **Unknown**

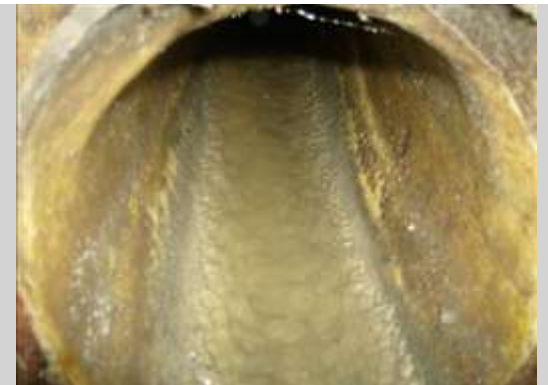
8 in. Circular Gravity Sewer Pipe In @ 6 O'Clock

Deposits: ☐ None ☐ Mud ☐ Sludge ☐ Debris ☒ **Grease**

Silt Depth: **0** (in.) Deposits Extent: **Light**

Infiltration: **None** Pipe Seal Cond: **Unknown**
